STRUCTURE CONDITION REPORT

BARGE CANAL FAIRPORT-LOCK 33

STRUCTURE CONDITION REPORT
BARGE CANAL - WESTERN SECTION
FAIRPORT TO LOCK 33
P.I.N. 4940.29 - 101

AUGUST 1975

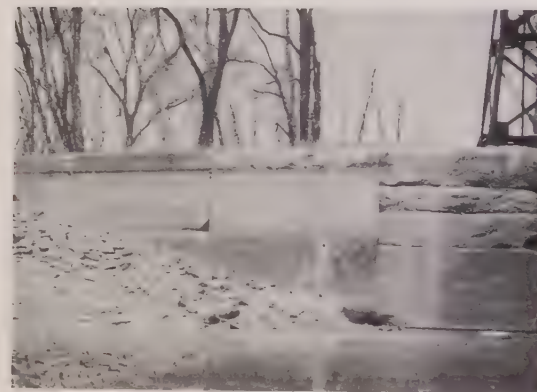
By sounding the concrete in the north abutment it was estimated that approximately 25 per cent of its surface area is deteriorated and delaminated. The west side of the 9 foot thick north abutment contains extensive deterioration in the upper portion. Cores #2 and #3, taken vertically through the top of this abutment, show that the deterioration extends to a depth of over 2 feet. The adjacent splay wall, which is three feet thick at the top and tapers to 9 feet thick at the bottom, appears to be in acceptable condition. Core #1, taken from this splay wall, contained only a few small fracture planes throughout its 13 inch depth. Core #1 had a compressive strength of 5,470 p.s.i.

North abutment, west half; note deterioration next to the gate

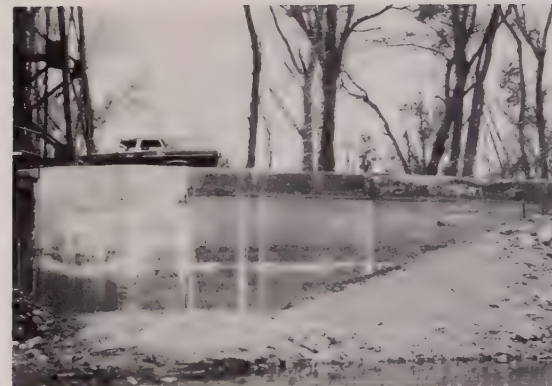
North abutment, east half; note repair adjacent to the gate

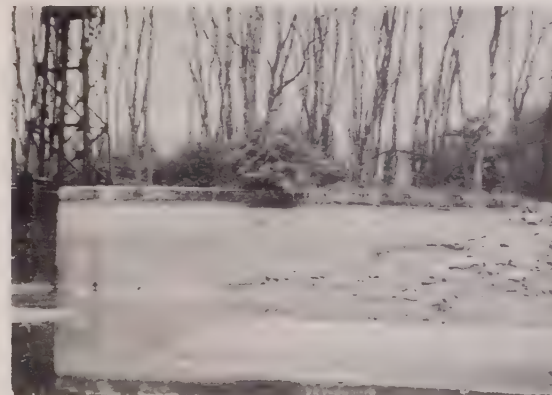
South abutment, west half

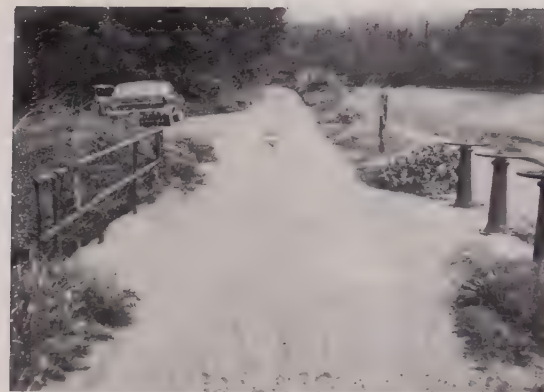
Top of Bushnell Basin Waste Gate looking east

Since the gate is not presently useable, repairs to the stop log columns are not necessary. Repairs to other areas containing delaminations and scaling are not required at this time.

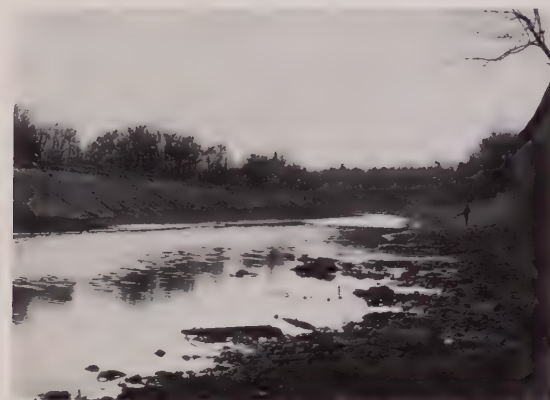
Concrete lined canal section as viewed from the Irondequoit Trough, looking East

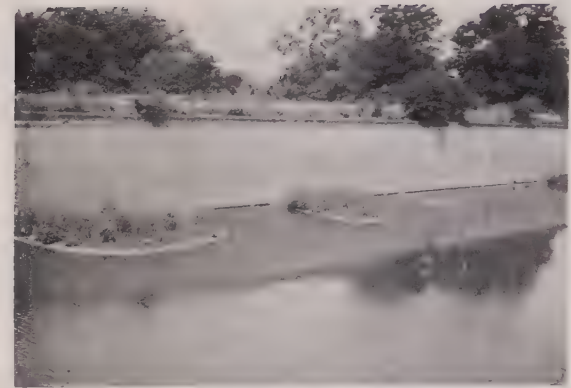
The concrete in the south side of the trough is in generally good condition with approximately 15 per cent of its surface showing some form of deterioration. Approximately 104 of the 128 panels show little or no deterioration, 20 panels show deterioration over about

South wall panels 93-98 from east end

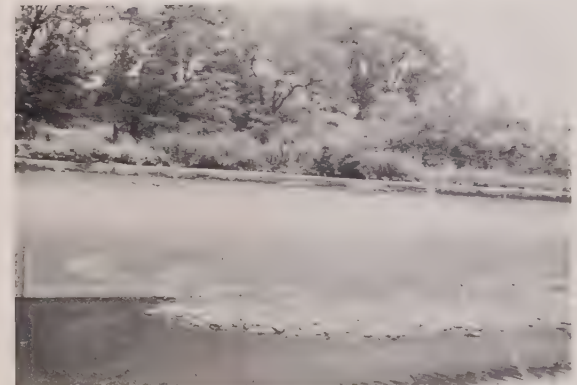
North wall panels 77-79 from east end
Center panel extensively repaired

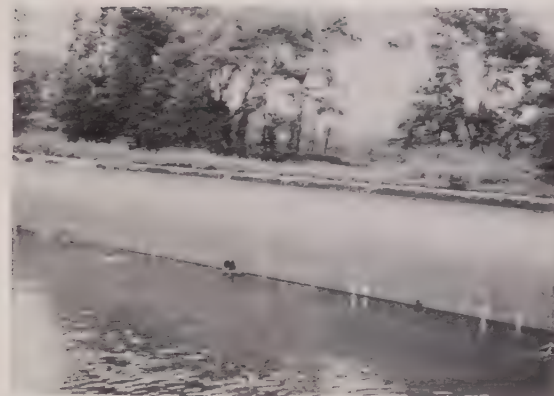
North wall, panels 112-115 from east end

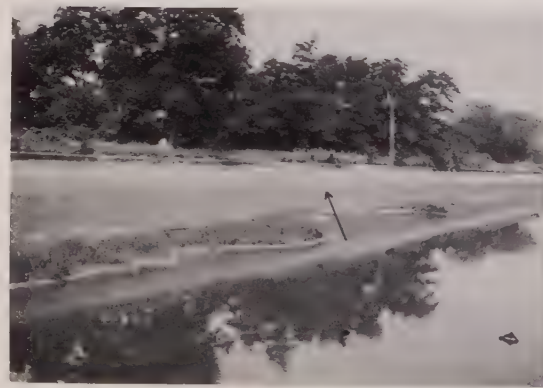
South wall panels 110-128 from east end
Note irregular horizontal crack at top of wall

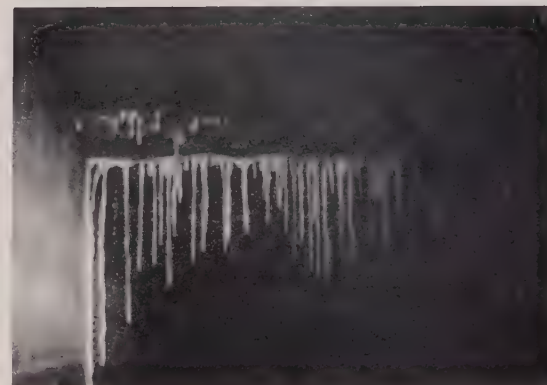
The inspection tunnels in both walls contained a few areas of efflorescence, but generally the concrete appeared to be in very good condition. All construction joints in these tunnels showed signs of leakage. This leakage is often indicated by the formation of soda straws. We conclude that the majority of this leakage has resulted from the infiltration of ground water, not

North inspection tunnel, west end, construction joint leakage indicated by soda straws

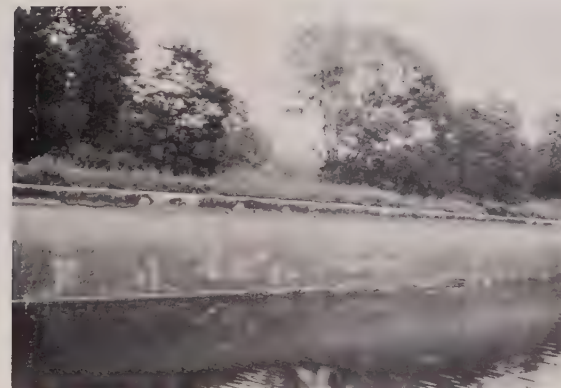
North wall, panels 121-115 from east end

No immediate repairs are required on these walls. Future repairs should include sealing all open joints with a cement grout.

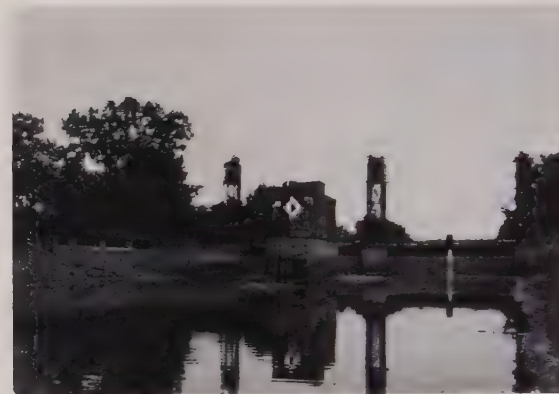
Cartersville Guard Gate, looking east

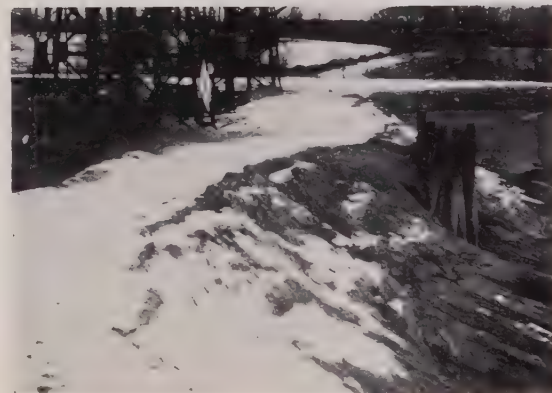
Sand dam on east side of Cartersville Guard Gate

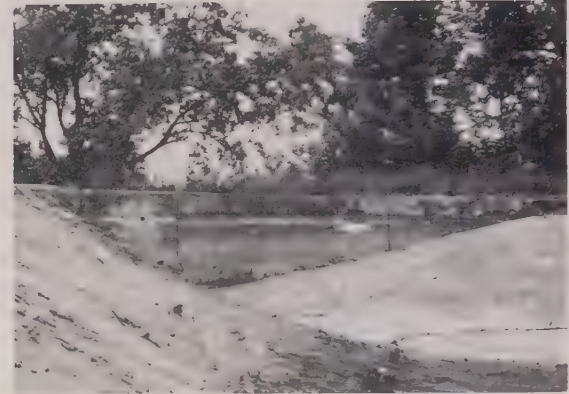
North east splay wall, Cartersville Guard Gate

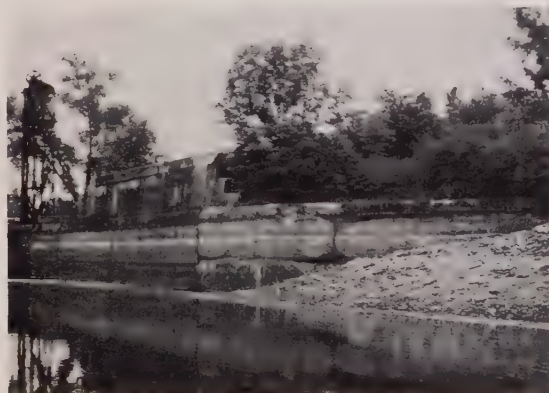
South Abutment and old railroad abutment,
Cartersville Guard Gate

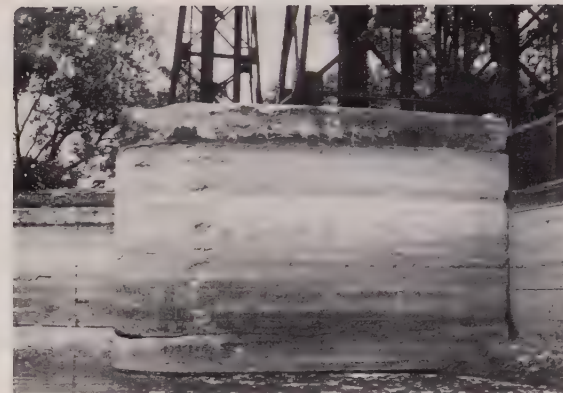
Center pier, south west section, Cartersville Guard Gate

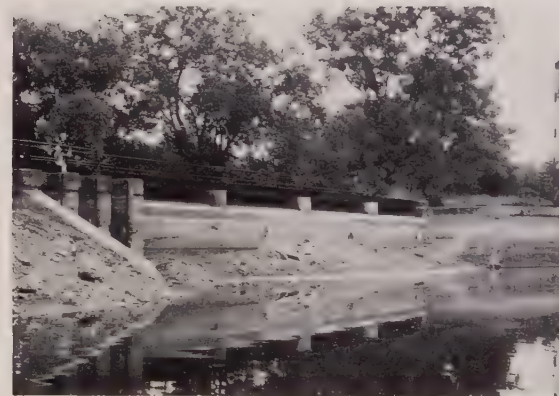
The back or canal side of the weir exhibits deterioration and numerous patches over 60 per cent of its surface. A patched section within 5 feet of the east abutment and 5 feet from the top of the weir appeared to contain the most deterioration. Core #2, obtained from this patched section, revealed that deterioration extended into the weir a depth of over 36 inches. The weir is approximately 6 feet thick in this area. A core was also drilled into the opposite side of this weir. This Core # 3 contained deteriorated concrete for a depth of 9.5 inches.

Cartersville Weir, south side

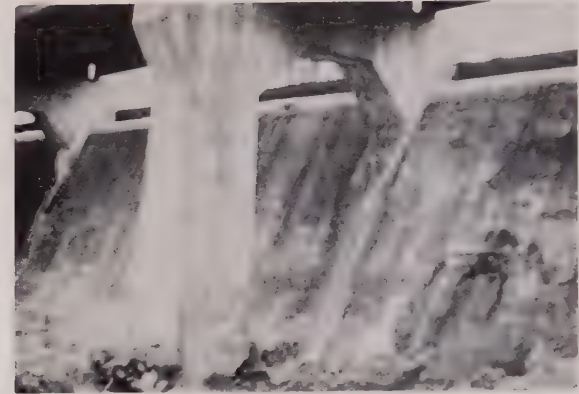
North side of Cartersville Weir and pier columns, looking east

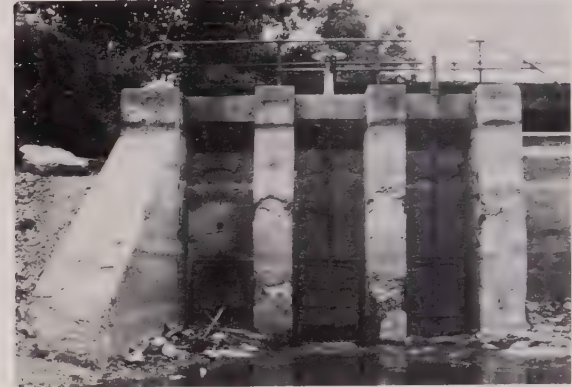
South side of Cartersville Waste Gate

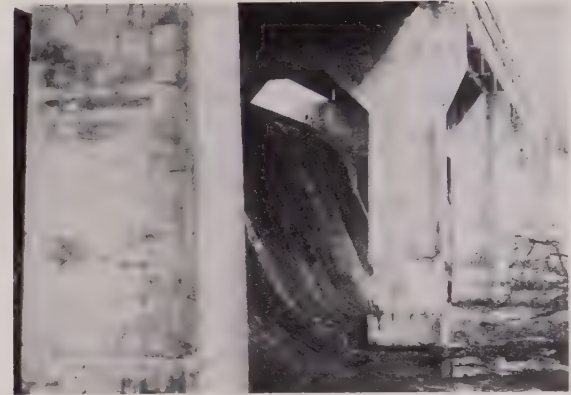
North side of Cartersville Weir and pier columns, looking west

The piers and pier caps supporting the tow path bridge are in poor condition. The concrete in these piers should be immediately repaired to insure support of this tow path bridge.

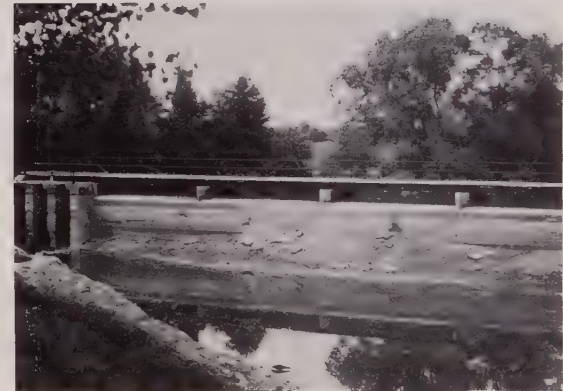
South side of Cartersville Weir and Waste Gate

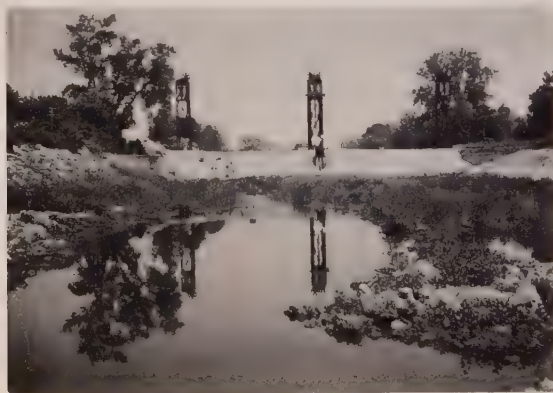
Cartersville Guard Gate, looking west
Sand dam on east side

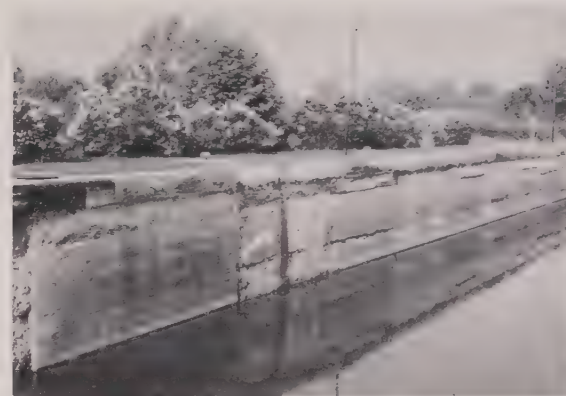
West guide wall, south side of lock

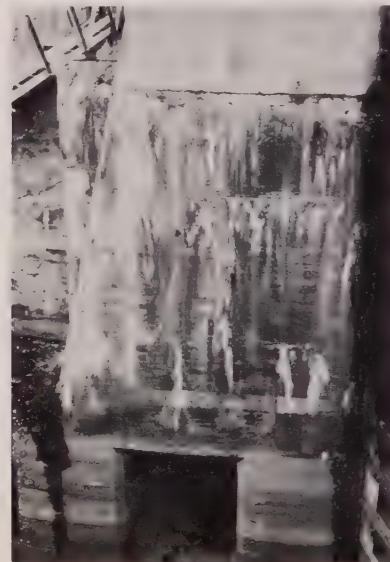
South main culvert discharge

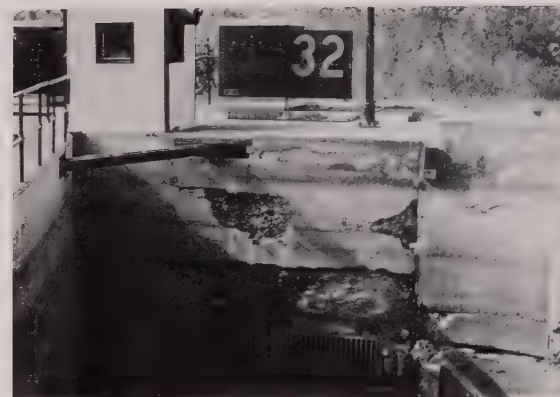
Trash racks of main culvert intake, south side
note core hole 2

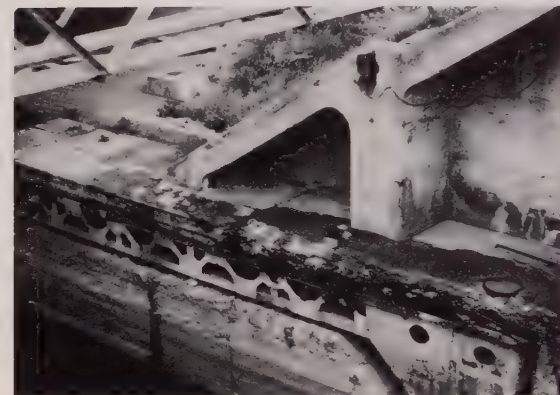
Extensive concrete deterioration was noted around the area of the eastern buffer beam on the lower guide wall. Overall, the surface area of the lower guide wall was estimated to be 50 per cent scaled

East guide wall and buffer beam

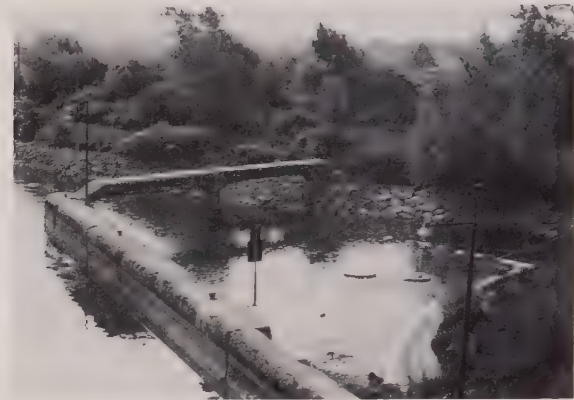
Considerable deterioration also existed in the concrete surrounding the large trash racks at the by-pass culvert entrance.

East guide wall and bypass tunnel outlet

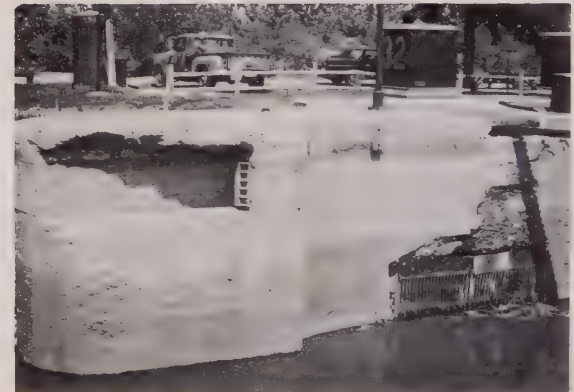
North west guide wall showing upper main culvert intake and buffer beam recess

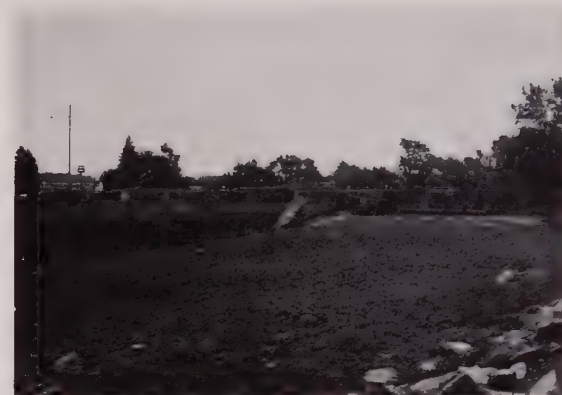
By-pass tunnel intake and crest of spillway, looking east

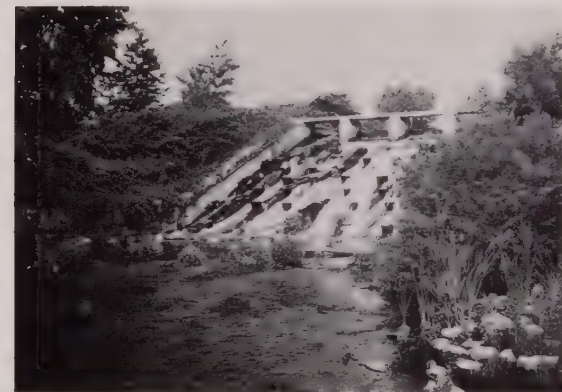
By-pass spillway tailrace

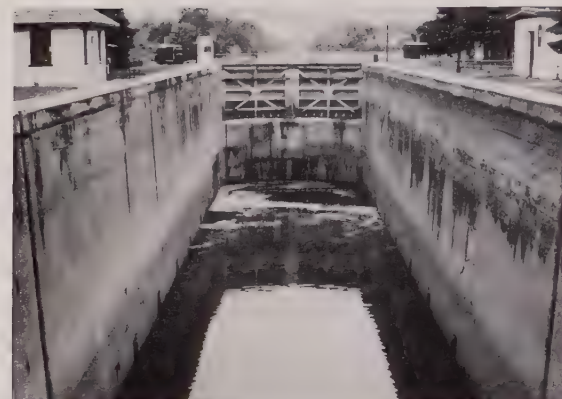
Lock 32 chamber, looking west

Lock 32 has been designated as a canal park and many visitors use the picnic areas and other facilities. The esthetic value of this lock would be greatly enhanced by repair of the surface deterioration.

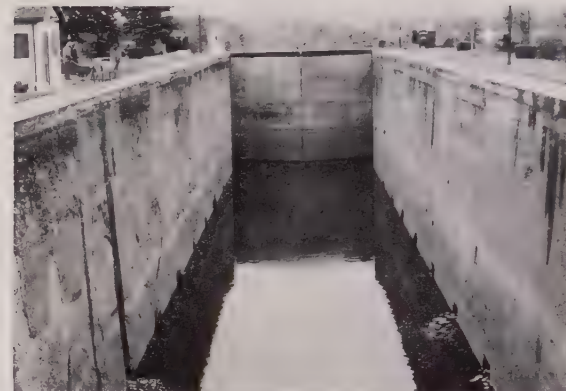
The south lock chamber wall has scaling and delamination over an estimated 60 per cent of its surface. Cores #7, 8, 10 and 11 contained deteriorated concrete from 5 to 14 inches in depth. Soundings along the lower 6 feet of this wall indicated that portions of these wall sections were in relatively good condition. Core #9, which was taken in one of these good sections, contained no deterioration and had a compressive strength of 6930 p.s.i.

Lock chamber, looking east

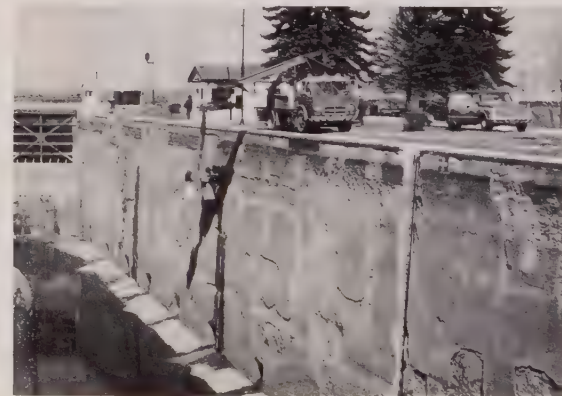
Coring north lock wall from "Snooper"

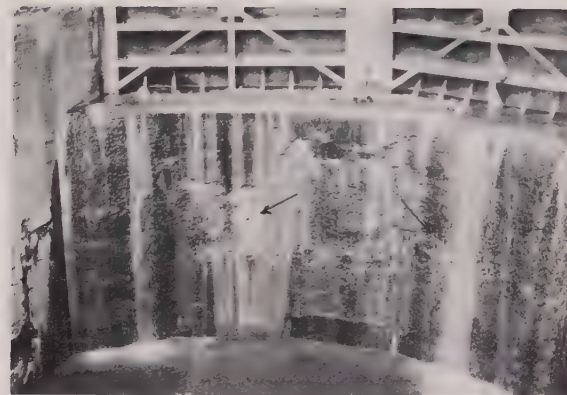
Sill under west lock gate, core holes 5 and 6, right to left

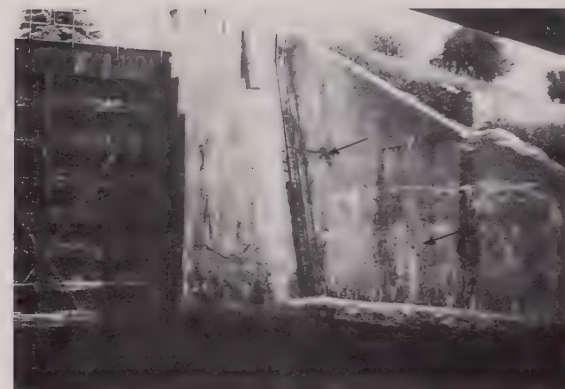
North east approach wall, core holes 25 and 26, left to right

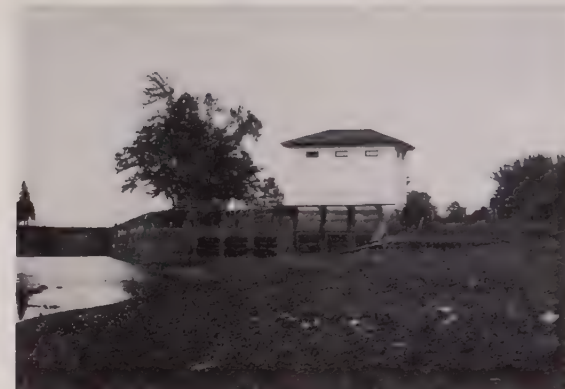
One minor problem, associated with this spillway, is the slow leakage of water recently noted at the bottom of the spillway pad when the canal is nearly full. This leakage has no effect on the function of the lock. The exact path of this water could not be determined. However, some of the possibilities are that the water could be flowing through the delaminated concrete pads, passing through a crack in a sheet piling wall or the concrete wall under the crest, or even flowing under the concrete pads.

Bypass tunnel intake, powerhouse intake, and spillway crest, left to right

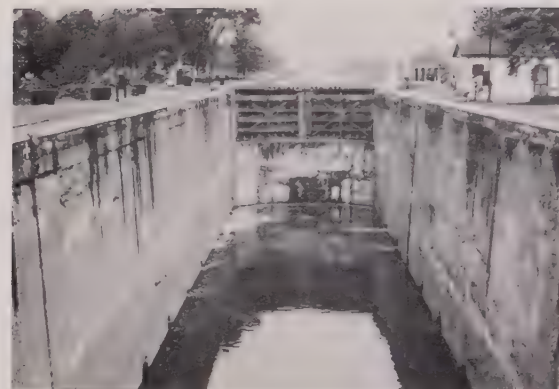
Lock chamber, looking west

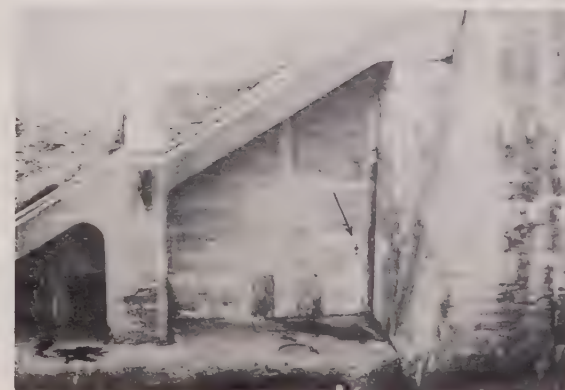
South east approach wall, note core hole 27 under stairs

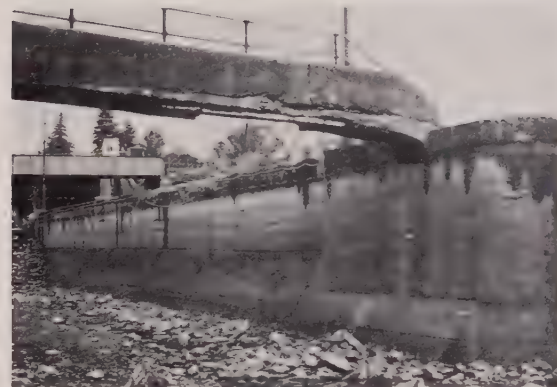
The lower guide wall is extensively scaled and deteriorated around the area of the east buffer beam. Similar deterioration exists around the area of the west buffer beam and both buffer beams at Lock 32. Overall, the lower guide wall was estimated to be 50 per cent scaled and delaminated with the major portion of the deterioration located on the upper section of the wall. An old pedestrian bridge at the east end of this wall is severely

deteriorated with its reinforcing steel completely exposed.

Pedestrian bridge and east guide wall, as seen from spillway discharge channel

The only serious condition noted at this lock was the pedestrian bridge located at the east end of the lower guide wall. Although only a secondary structure, which has no effect on the operation of the lock, this bridge should be removed or barricaded.

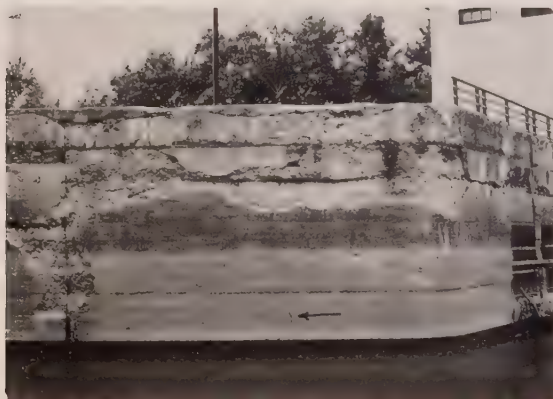
West guide wall and bypass tunnel intake, note vertical crack in wall, center

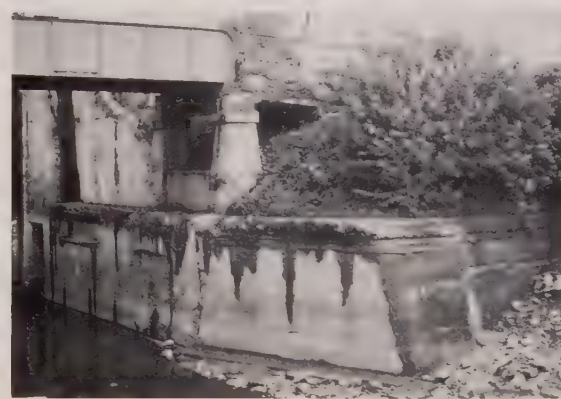
East guide wall, north side
